PROCEDURE

Note: The following work was performed on an E90. Other models may vary slightly.

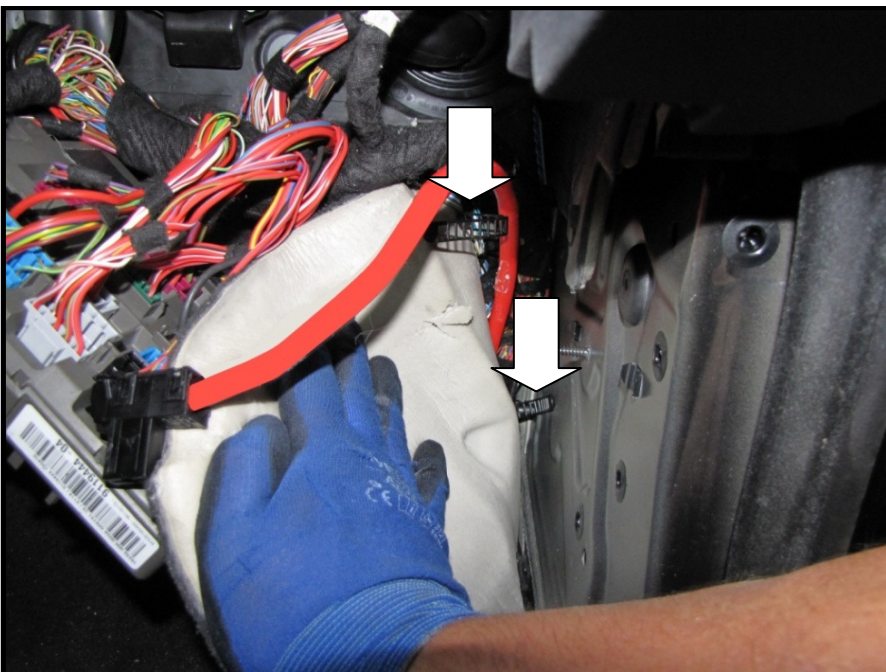
11. Open the retaining straps and pull the positive battery cable out as far as possible.

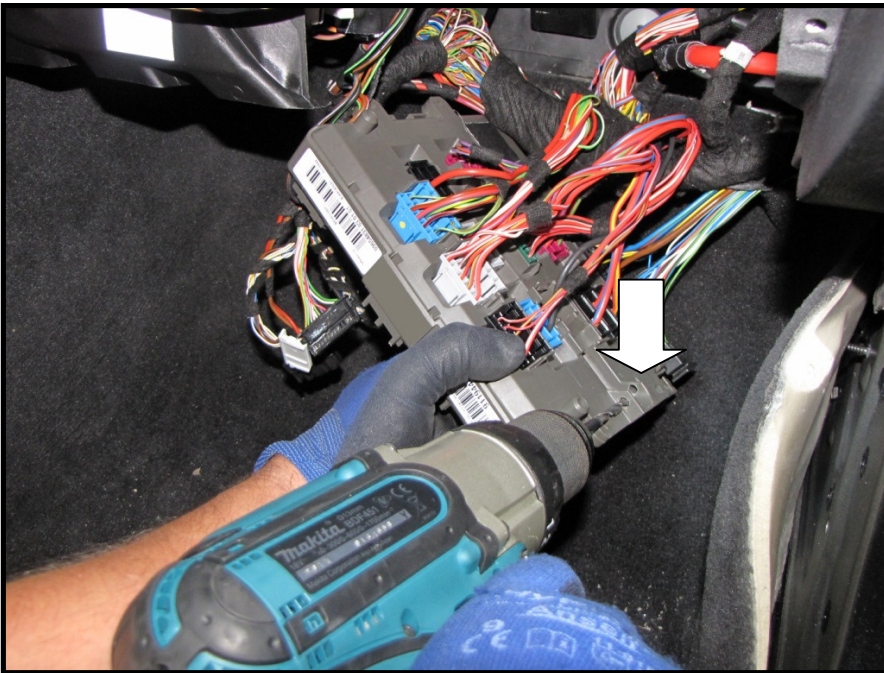
12. Pre-drill both bridges of the power distribution box at the area (as shown) with a 2mm drill and then with a 5 mm drill. **This step may not be necessary for E89.**

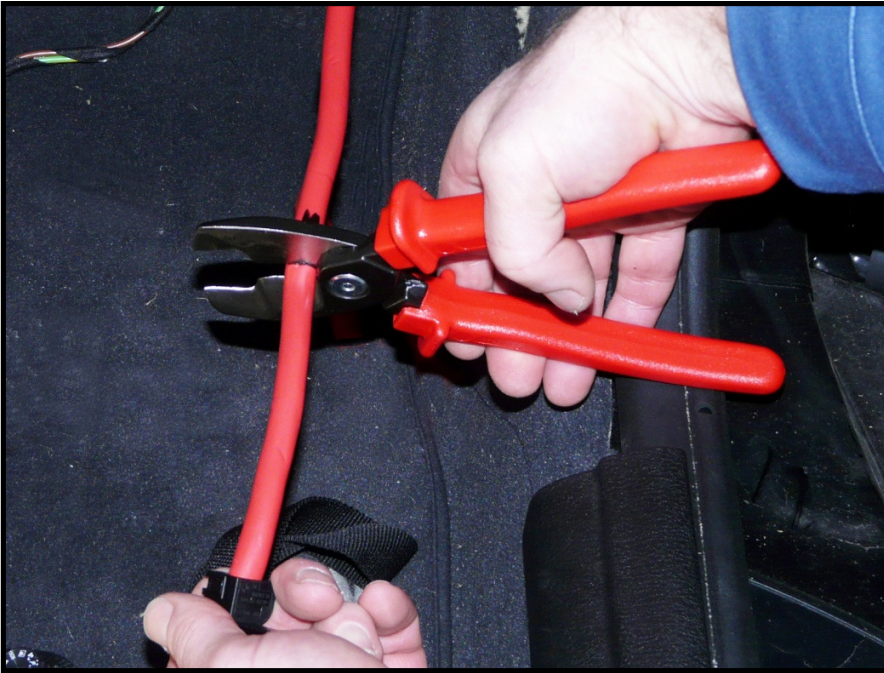
14. Cut the positive cable at the mark using special tool 2 337 974.

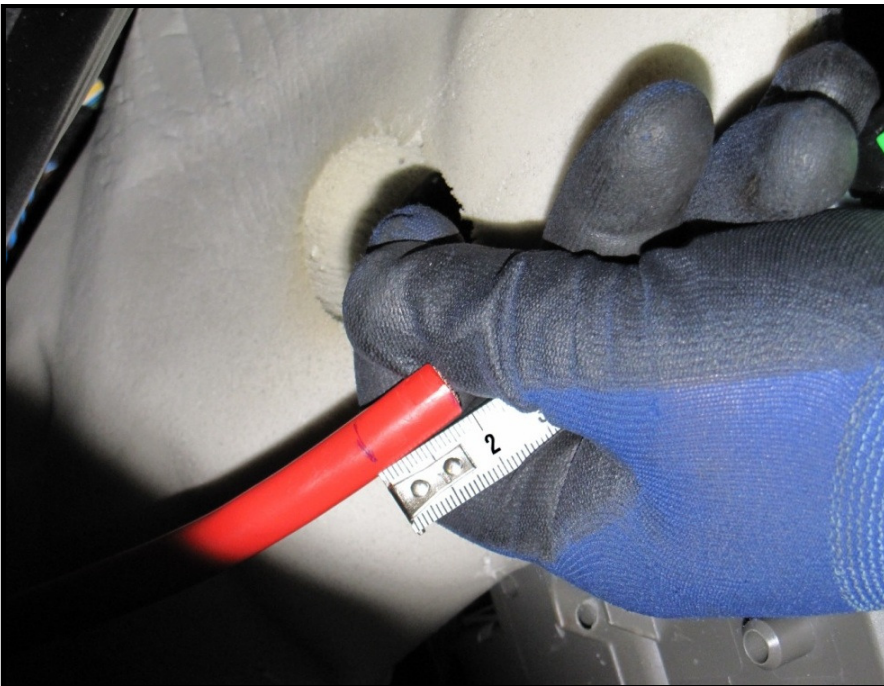
15. At the cut-off end of the positive cable, measure and mark 2 cm from the end of the cable.

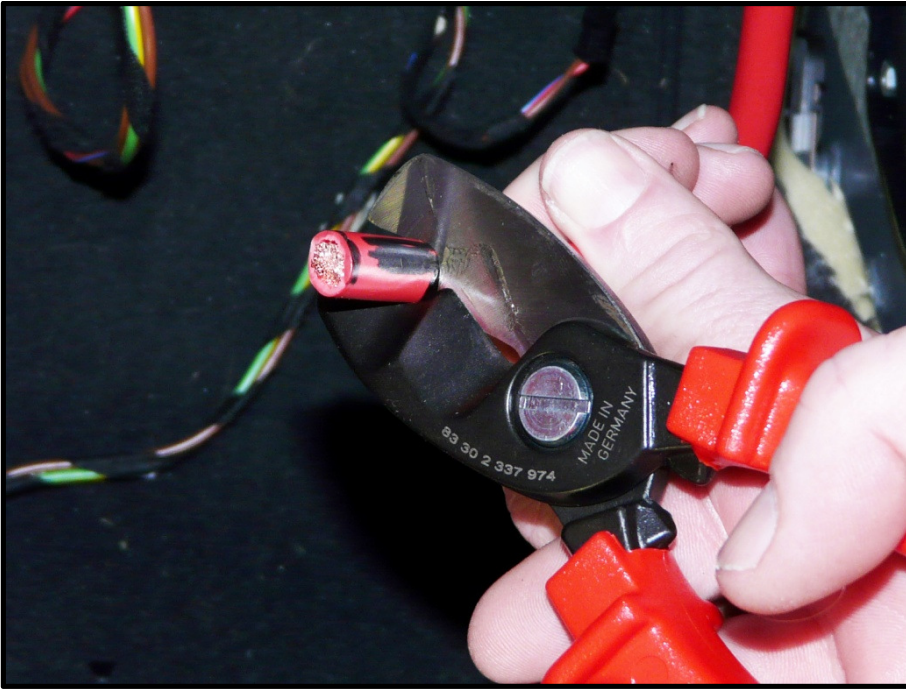
16. Strip off the insulation using the outer cutting jaws of the special tool. Be careful that you do not cut any of the cable strands while penetrating the insulation sheath.

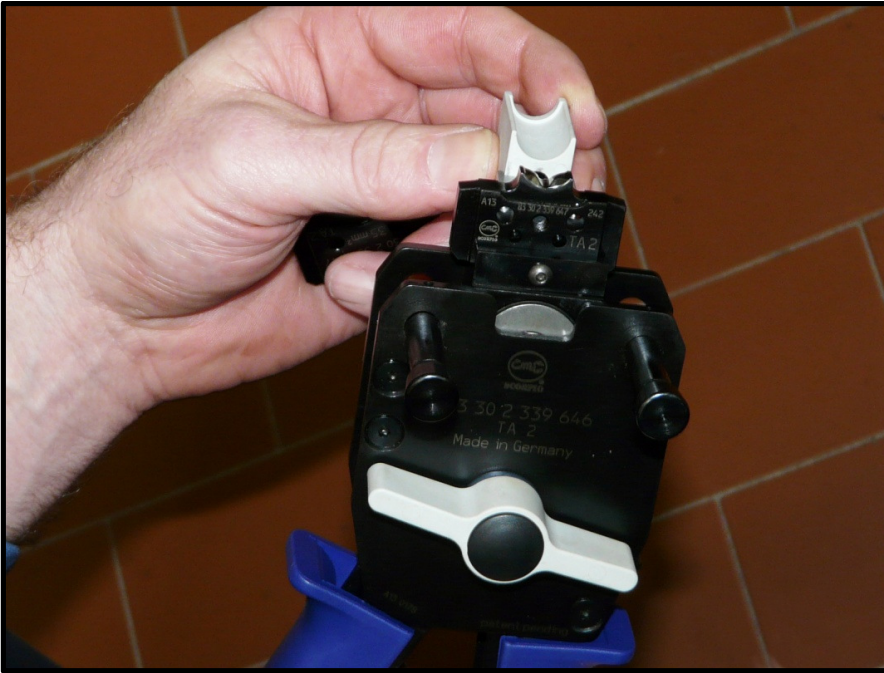
19. Insert the lower die set until it is locked into the tool.

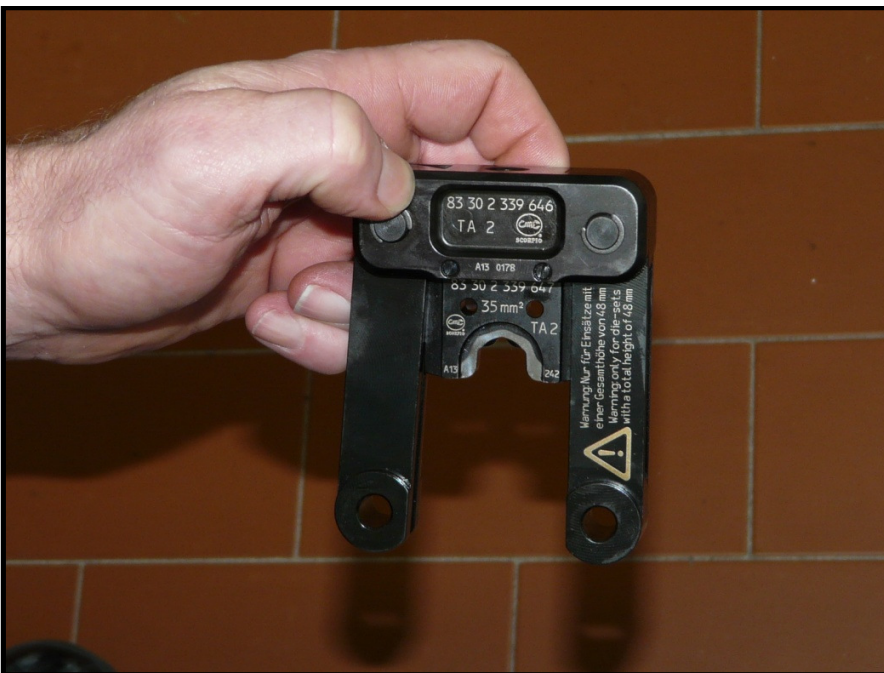
20. Insert the upper die into the tool (as shown) until it locks in place.

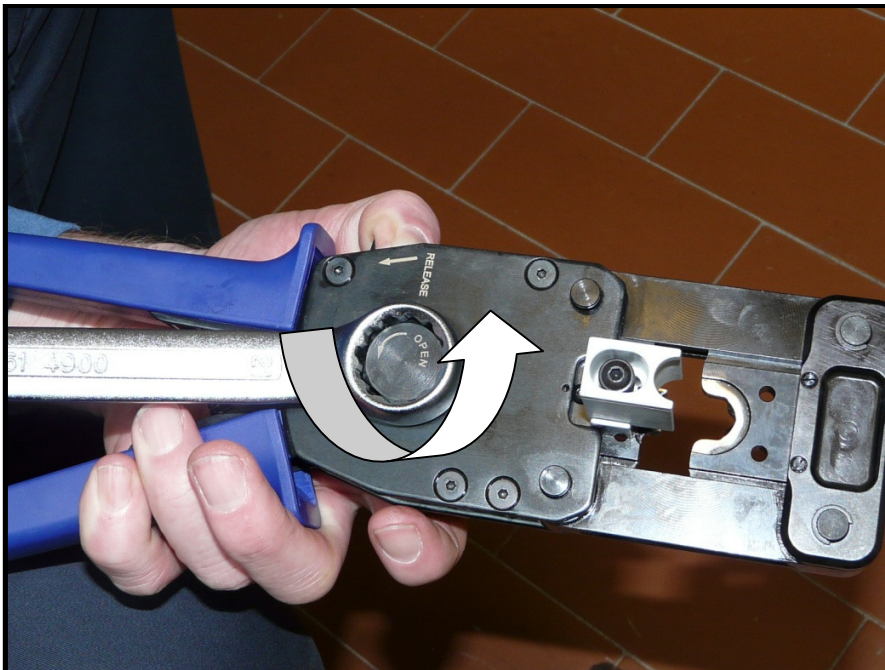
22. Using the wrench supplied with the tool, open the tool by holding the release lever and turning the nut counterclockwise.

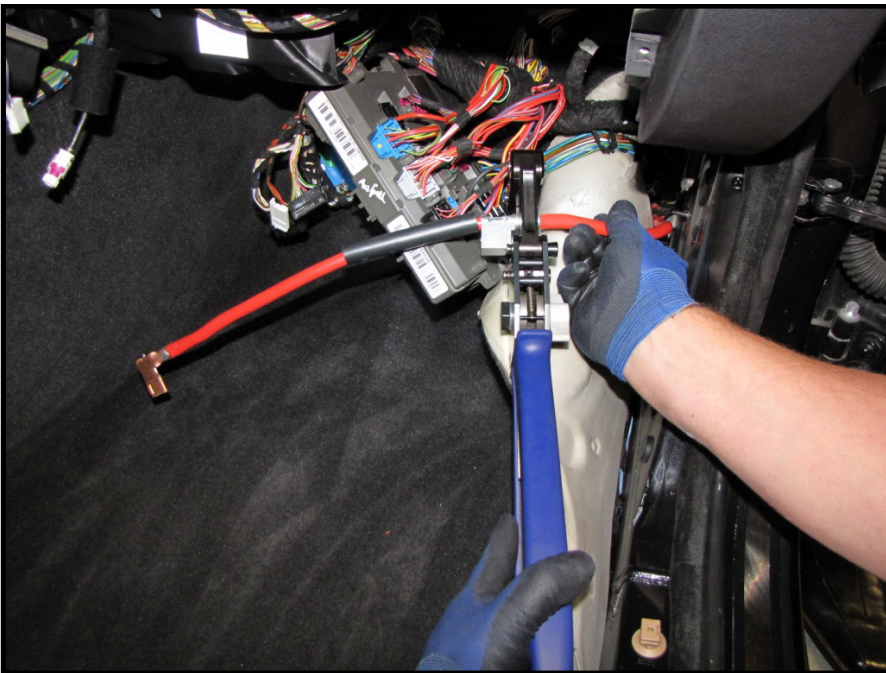
27. Crimp the butt connector using the crimping pliers. **The crimping tool will automatically release when it reaches the final crimping point.**
