Service Action: N54 Program Control Units (DME for HDP)

E60, E61, E71, E82, E88, E90, E92, E93, F01, F02 with the N54 engine produced from 02/06 to 03/10

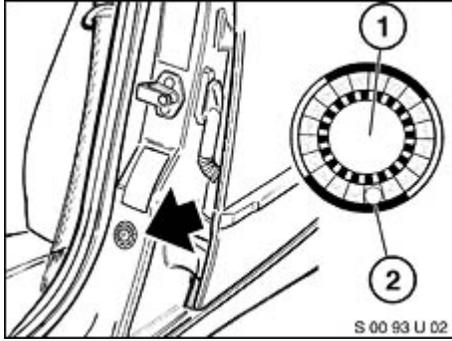
LABEL INSTRUCTIONS

This Service Action has been assigned code number **566**. After the vehicle has been checked and/or corrected, obtain a label (SD 92-380) and:

- A. Emboss your BMW center warranty number in the middle of the label (1);
- B. Punch out code number **566** (2), printed on the label; and
- C. Affix the label to the **B**-pillar as shown.

In order to determine whether a specific vehicle has had this Service Action completed or is affected by this Service Action, first check the B-pillar label for code number **566**. If code number **566** has been punched out, the campaign has already been performed. If code number **566** has not been punched out, it will be necessary to utilize the "Service Menu" of DCSnet (Dealer Communication System) or the Key Reader. Based on the response of the system, either proceed with the corrective action or take no further action.
